Manhole Inspection Summary

Manhole # S43CC_017MH

Location Address: **834 n bond st**

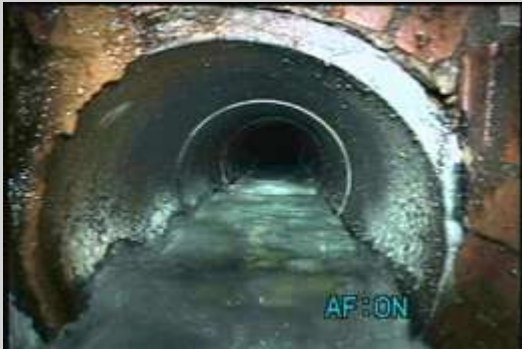
12 O'Clock Outflow

15 in. Circular Gravity Sewer
Pipe Out @ 12 O'Clock

Invert Depth: **18.66** (ft.) Flow Characteristics: **Fast**

Infiltration: **None** Pipe Seal Cond: **Unknown**

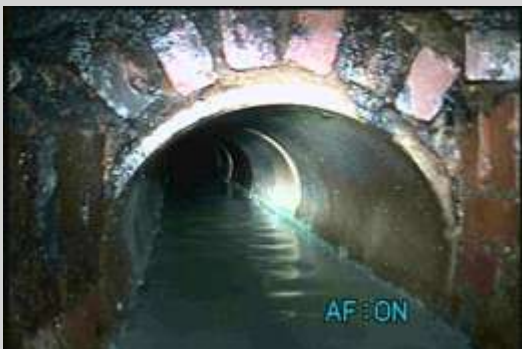
5 O'Clock Inflow

15 in. Circular Gravity Sewer
Pipe In @ 5 O'Clock

Invert Depth: **18.41** (ft.) Flow Characteristics: **Fast**

Infiltration: **None** Pipe Seal Cond: **Unknown**

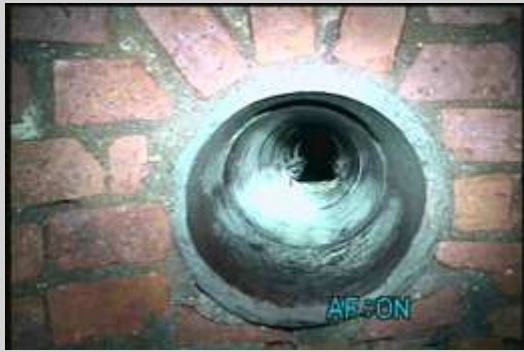
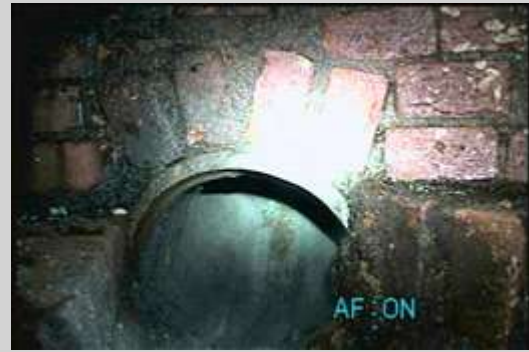
9 O'Clock Inflow

8 in. Circular Gravity Sewer

Drop In @ 9 O'Clock

Infiltration: **None** Pipe Seal Cond: **Unknown**

Drop Condition: **Open**
